**FRENCH RIVER BASIN
LEICESTER, MASSACHUSETTS**

**STILES RESERVOIR DAM
MA 00983**

**PHASE I INSPECTION REPORT
NATIONAL DAM INSPECTION PROGRAM**

APRIL 1979

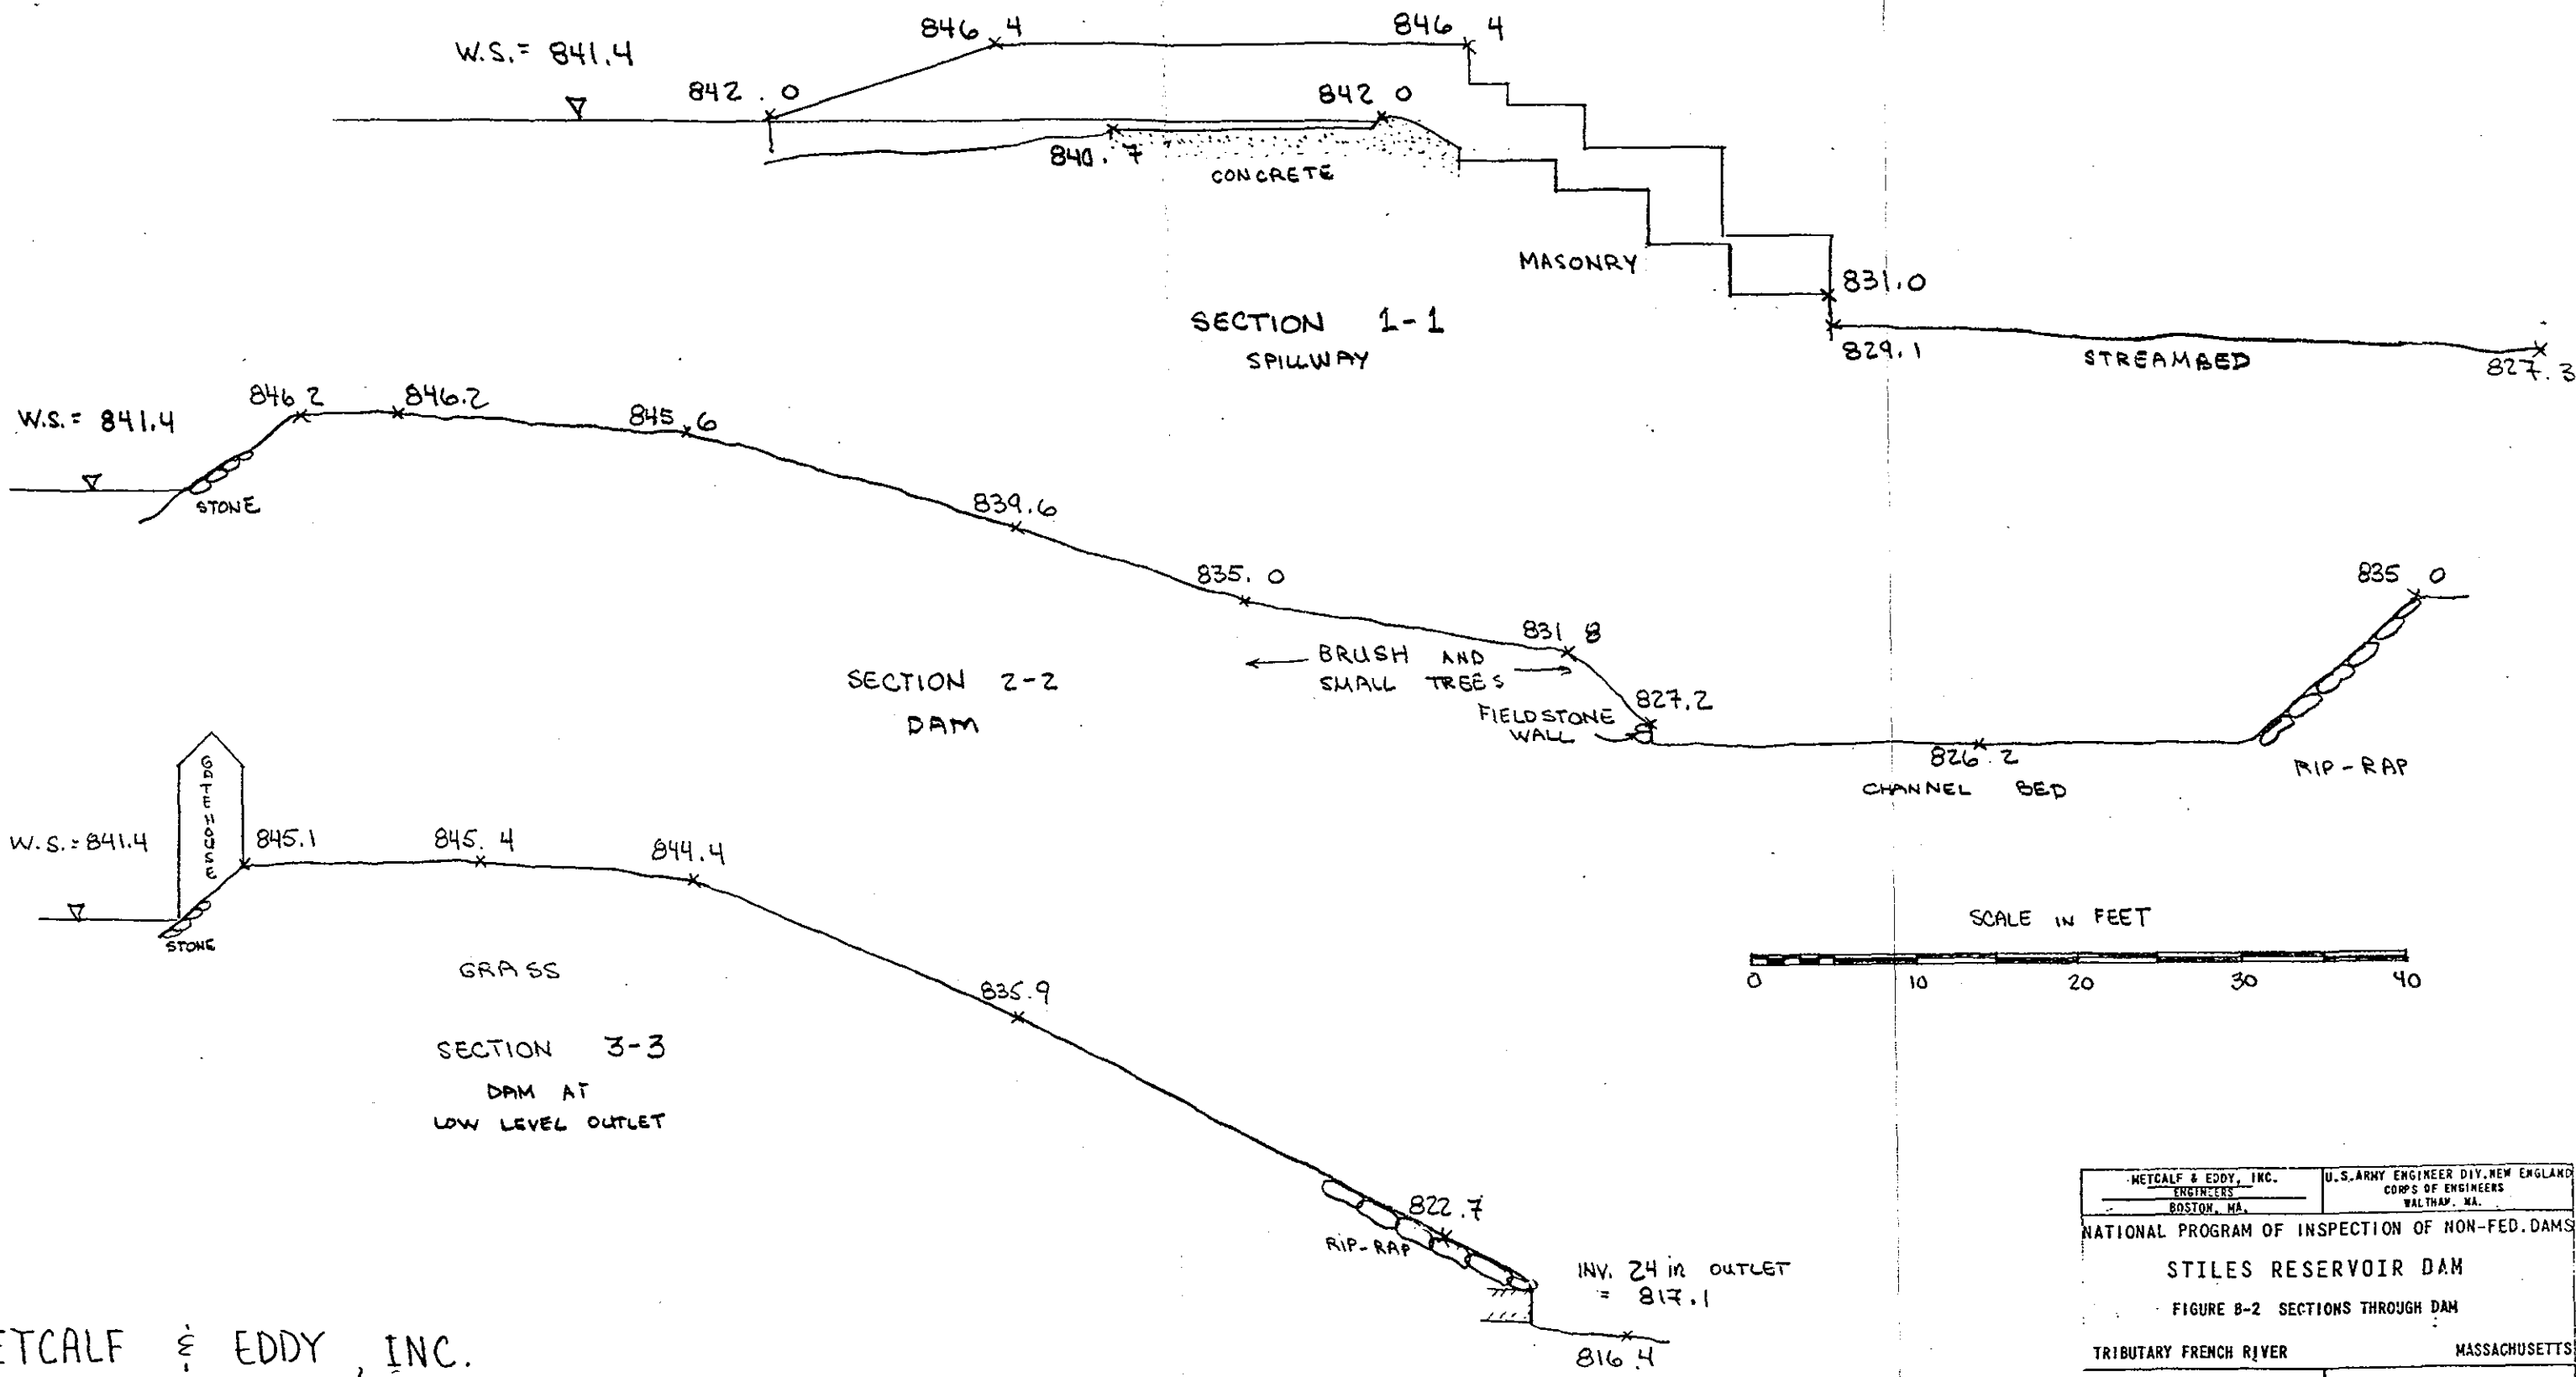
METCALF & EDDY, INC. ENGINEERS BOSTON, MA.	U.S. ARMY ENGINEER DIV. NEW ENGLAND CORPS OF ENGINEERS WALTHAM, MA.
NATIONAL PROGRAM OF INSPECTION OF NON-FED. DAMS	
STILES RESERVOIR DAM	
FIGURE B-1 PLAN OF DAM	
TRIBUTARY FRENCH RIVER	MASSACHUSETTS
SCALE: 1" = 50'	DATE: JANUARY, 1979

Riprap on the upstream slope appeared to be in fair condition. Some slight depression along the crest at the downstream side was noted as well as some small holes less than 12 inches in diameter and 6 inches deep. There were trees and small brush along some areas of the downstream slope. The toe of the dam had many trees and saplings growing. A large area of standing water was noted in the downstream area to the north of the outlet discharge channel (see Figure B-1).
